# Deterioration of Steel Sheet Pile Groins At Palm Beach, Florida\*

By **CULBERTSON W. ROSS**

\*A paper presented at the Fifth Annual Conference of The National Association of Corrosion Engineers at Cincinnati, Ohio, April 11-14, 1949.

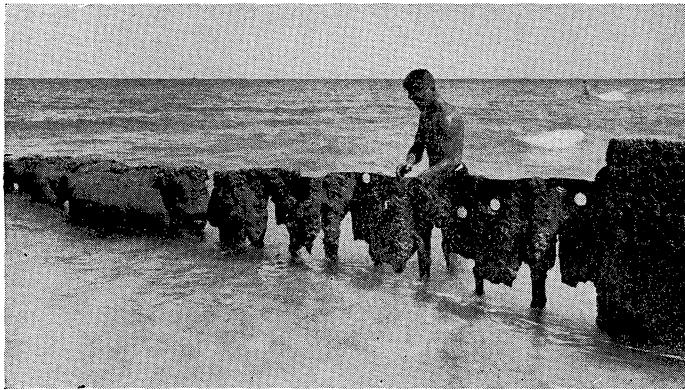
Figure 1—Serious structural deterioration of a groin at Palm Beach, Fla., after 12 years' exposure. The marine life, sabellaria, may be noted.

The rapid deterioration of the steel groins at Palm Beach was caused by the abrasive action of sand carried by the waves. Abrasion is most intense for an inch or two above the sand line but is spread over a wider area by changes in the position of the sand line. The abrasion removed the rust from the piles and permitted rapid corrosion of the exposed steel.

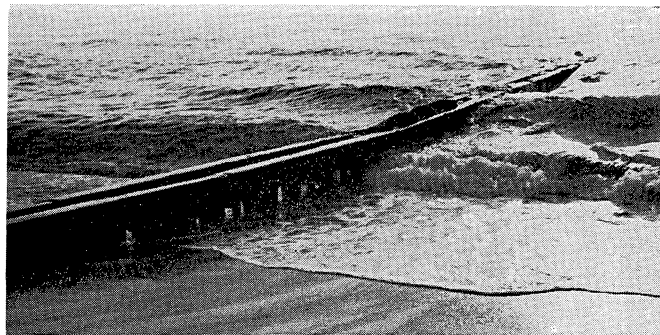
There were other evidences of sand abrasion in addition to the high rate of loss of thickness. The steel frequently appeared bright and polished at the sand line. Paint had disappeared from the piles in bands parallel to the sand line within 3 months after the groins were built. Most of the paint was gone from the visible portion of the piles within 6 months after installation. The force of sand erosion also was observed in piles which developed large holes near the sand line while their steel tops retained almost their original thickness.

Figure 4—Holes at the sand line, Groin 139N after 5.3 years' exposure.
